Shock and Vibration Test Report GEODE-OSB and GEODE-JSP Systems

May 13, 2024

This document provides a test report for shock and vibration tests performed on Geode-OSB and Geode-JSP rugged systems. The tests reported here were conducted on April 18, 2024 at Envitest Laboratories in Bangalore Electronics City, India: <https://www.envitestlab.com/about-us/>

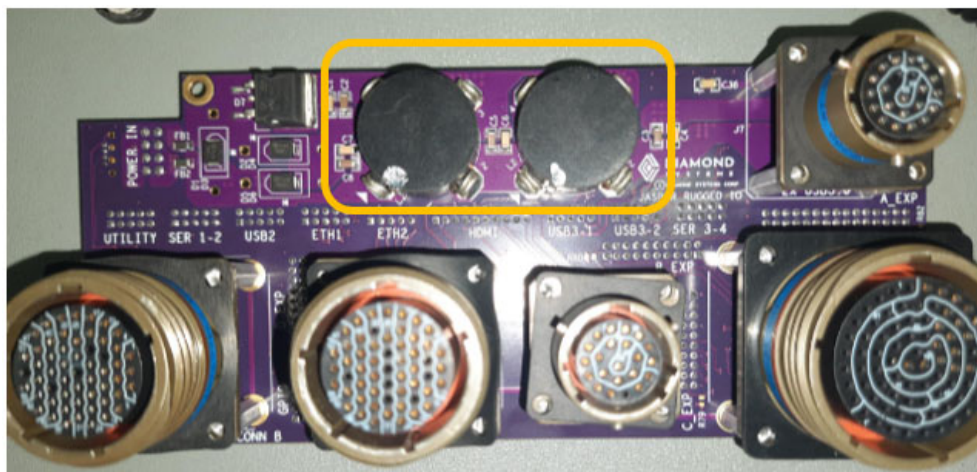
Figure 3: Glued components on Jasper Rugged IO Board

As a standard practice during production, DP460 Epoxy adhesive is applied on L1, L2, L3 and L4 Common Mode Chokes.

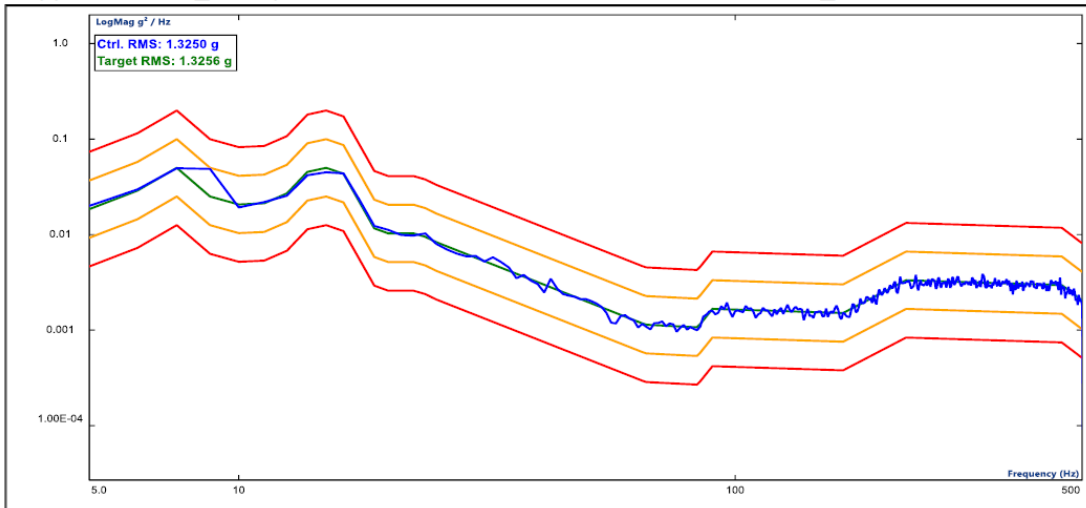
Graph 1: X-Axis Random vibration test

Axis	Frequency (Hz)	Acceleration Spectral Density (G ² /Hz)	Duration & Overall (gRMS)
Longitudinal Axis (X-Axis)	5	0.0407	40 Minutes duration 1.45 gRMS
	6	0.044155	
	7	0.11	
	8	0.11	
	9	0.0425	
	12	0.0425	
	14	0.074	
	16	0.074	
	19	0.02	
	23	0.0103	
	25	0.00833	
	66	0.00114	
	84	0.00107	
	90	0.00167	
	165	0.00151	
	221	0.00333	
	455	0.00296	
500	0.00204

Total elapsed time: 00:41:08 Full level elapsed time: 00:40:00 Run Start Time: Apr-18-2024 17:08:23

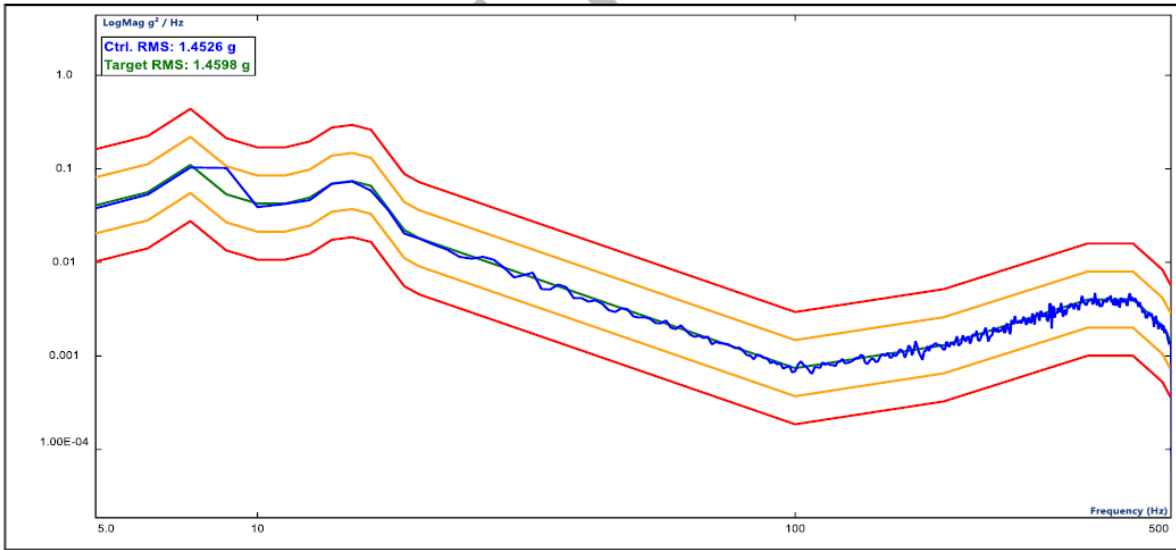
Graph 2:-Y-Axis random vibration test

Axis	Frequency (Hz)	Acceleration Spectral Density (G ² /Hz)	Duration & Overall (gRMS)
Transverse Axis (Y-Axis)	5	0.0407	40 Minutes duration 1.45 gRMS
	6	0.044155	
	7	0.11	
	8	0.11	
	9	0.0425	
	12	0.0425	
	14	0.074	
	16	0.074	
	19	0.02	
	100	0.00074	
	189	0.0013	
	350	0.004	
	425	0.004	
	482	0.0021	
500	0.00142

Total elapsed time: 00:41:08 Full level elapsed time: 00:40:00 Run Start Time: Apr-18-2024 19:30:02

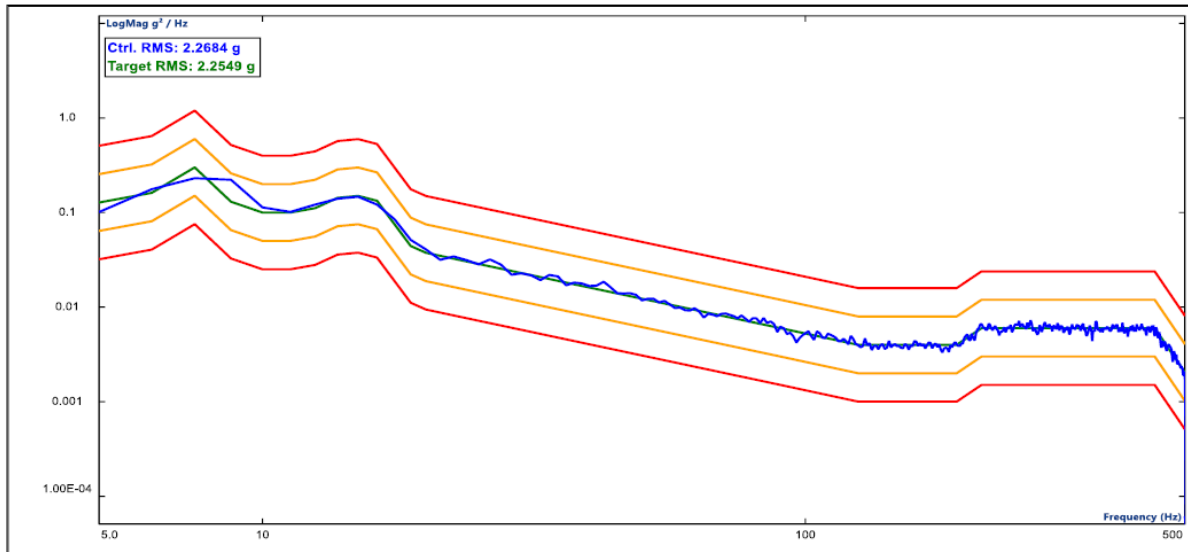
Graph 3:-Z-Axis random vibration test

Axis	Frequency (Hz)	Acceleration Spectral Density (G ² /Hz)	Duration & Overall (gRMS)
Vertical Axis (Z-Axis)	5	0.12765	40 Minutes duration 2.24 gRMS
	6	0.12926	
	7	0.3	
	8	0.3	
	9	0.1	
	12	0.1	
	14	0.15	
	16	0.15	
	19	0.04	
	90	0.006	
	125	0.004	
	190	0.004	
	211	0.006	
	440	0.006	
500	0.00204

Total elapsed time: 00:41:37 Full level elapsed time: 00:40:00 Run Start Time: Apr-18-2024 11:41:18

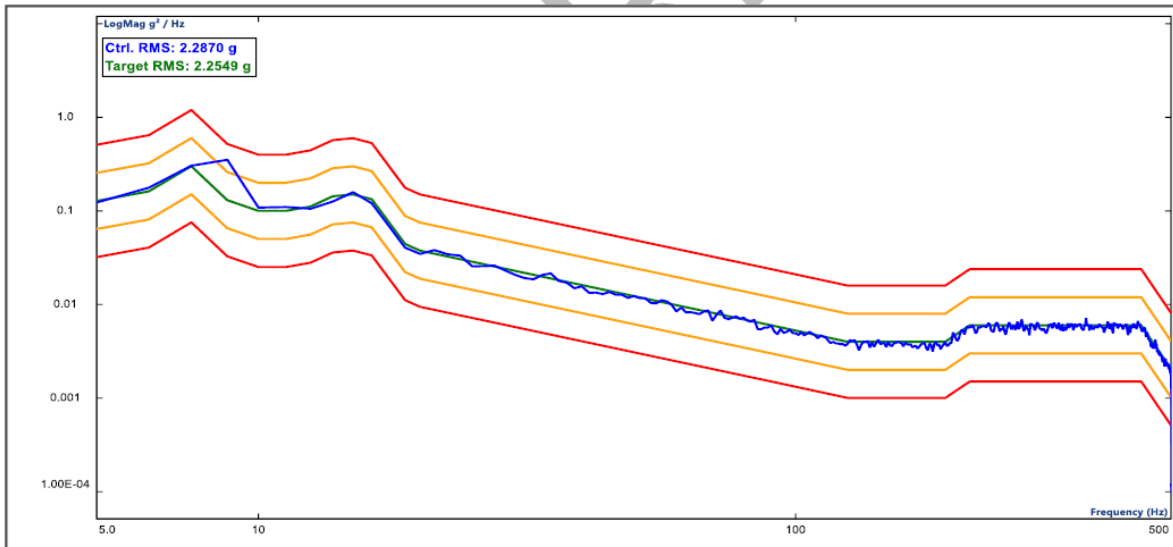
Graph 4: X-Axis Envelope random vibration test

Axis	Frequency (Hz)	Acceleration Spectral Density (G ² /Hz)	Duration & Overall (gRMS)
Vertical, Longitudinal & Transverse Axes (Z, X & Y Axes)	5	0.12765	40 Minutes duration 2.24 gRMS
	6	0.12926	
	7	0.3	
	8	0.3	
	9	0.1	
	12	0.1	
	14	0.15	
	16	0.15	
	19	0.04	
	90	0.006	
	125	0.004	
	190	0.004	
	211	0.006	
	440	0.006	
500	0.00204

Total elapsed time: 00:41:07 Full level elapsed time: 00:40:00 Run Start Time: Apr-18-2024 18:00:44

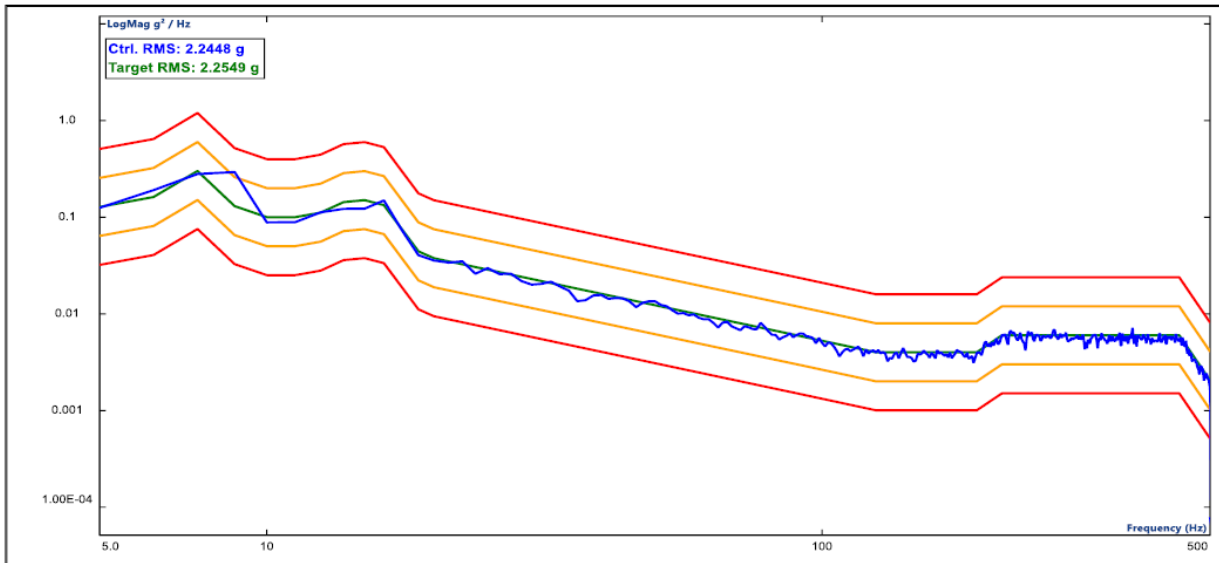
Graph 5:-Y-Axis Envelope random vibration test

Total elapsed time: 00:41:32 Full level elapsed time: 00:40:01 Run Start Time: Apr-18-2024 20:14:39

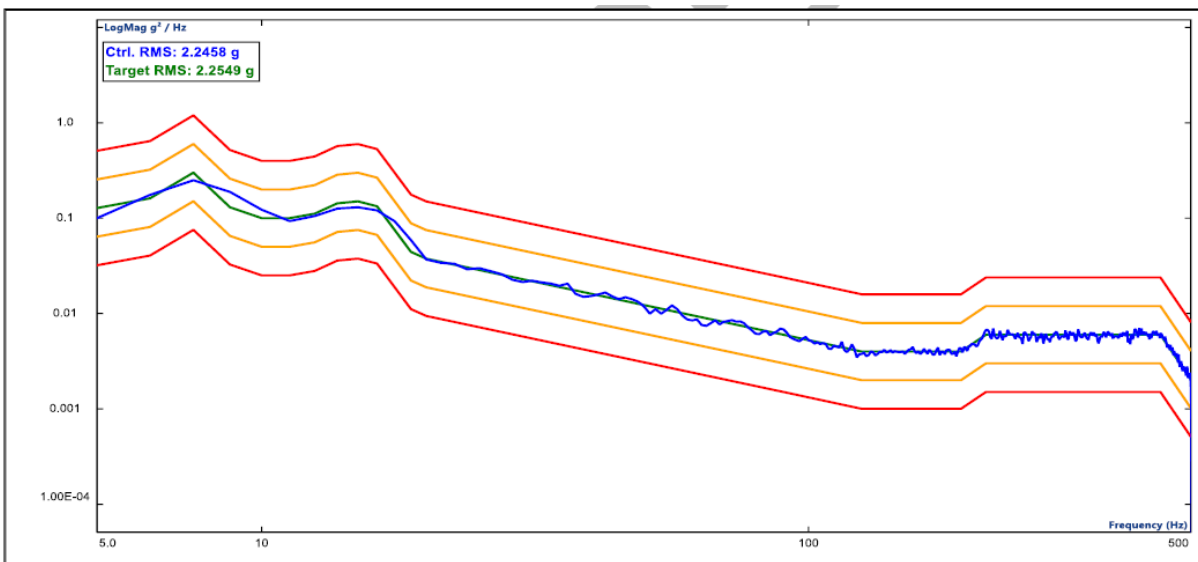
Graph 6:-Z-Axis Envelope random vibration test

Total elapsed time: 00:42:36 Full level elapsed time: 00:40:02 Run Start Time: Apr-18-2024 13:18:20

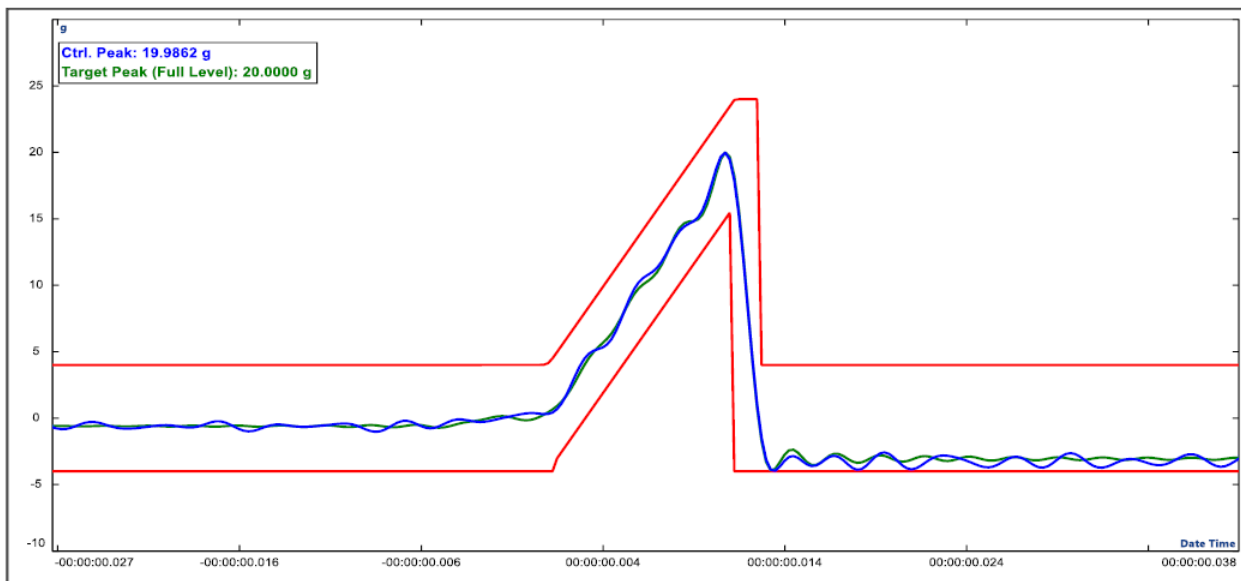
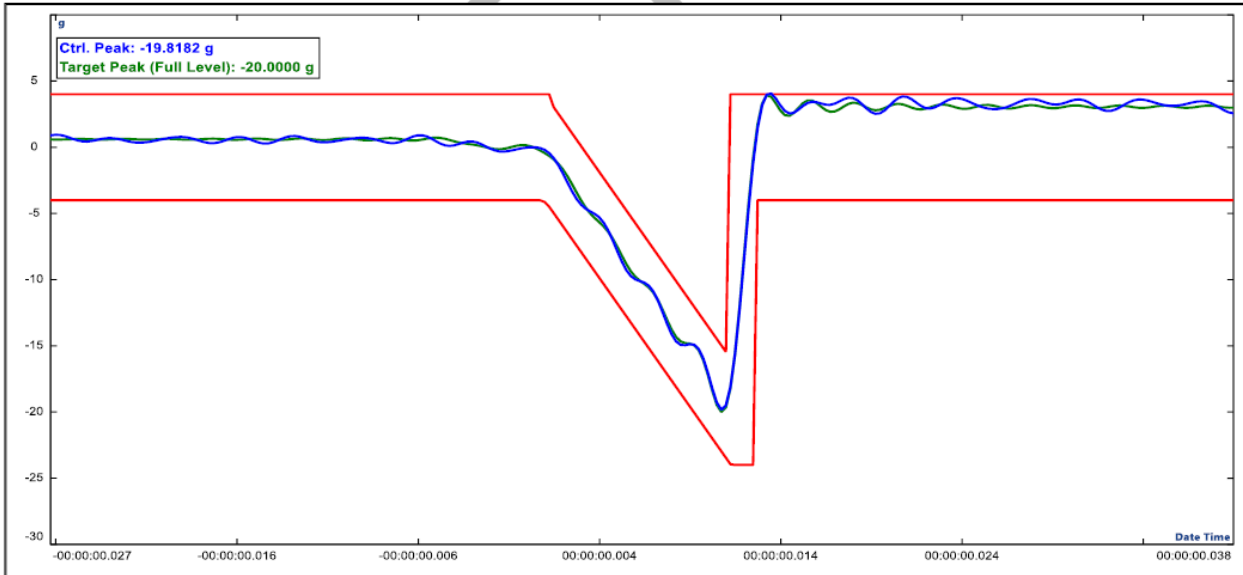
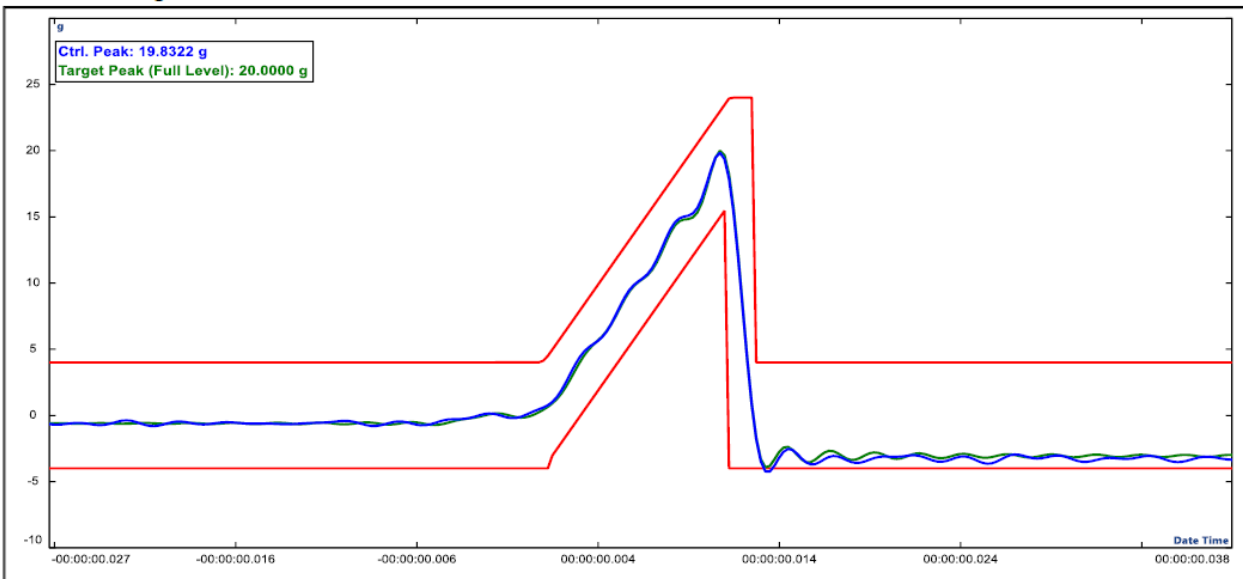
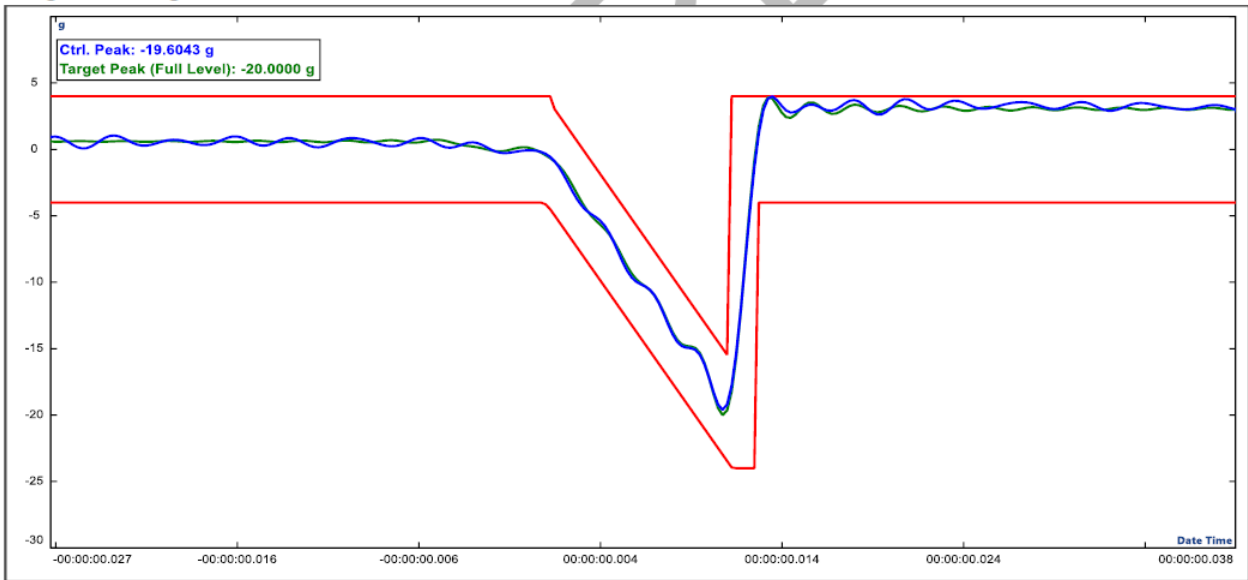
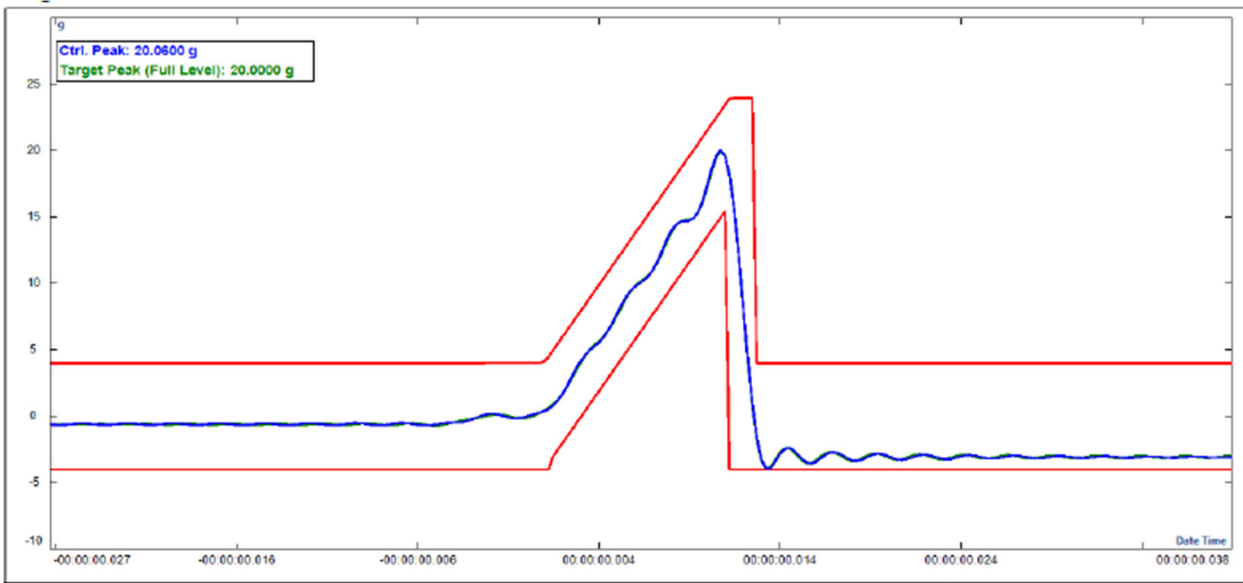
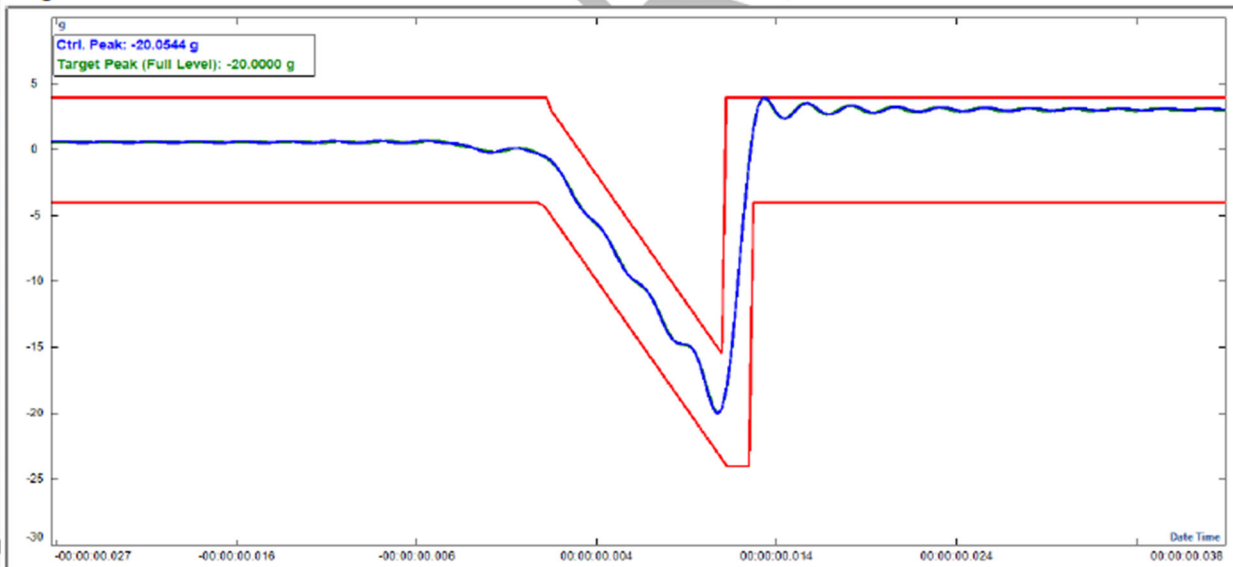
Axis	Peak Acceleration (g)	Pulse width (ms)	Shock Spectrum & No of Pulse / axis
X, Y & Z Axes	20	11	Terminal peak saw tooth, 3 shocks/direction, Total 18 shocks.
X, Y & Z Axes	40	11	Terminal peak saw tooth, 3 shocks/direction, Total 18 shocks.

Graph 7:-X Axis 20g 11ms positive direction

Graph 8: X Axis 20g 11ms negative direction

Graph 9:- Y Axis 20g 11ms positive direction

Graph 10: Y Axis 20g 11ms negative direction

Graph 11: Z Axis 20g 11ms positive direction

Graph 12:- Z Axis 20g 11ms negative direction

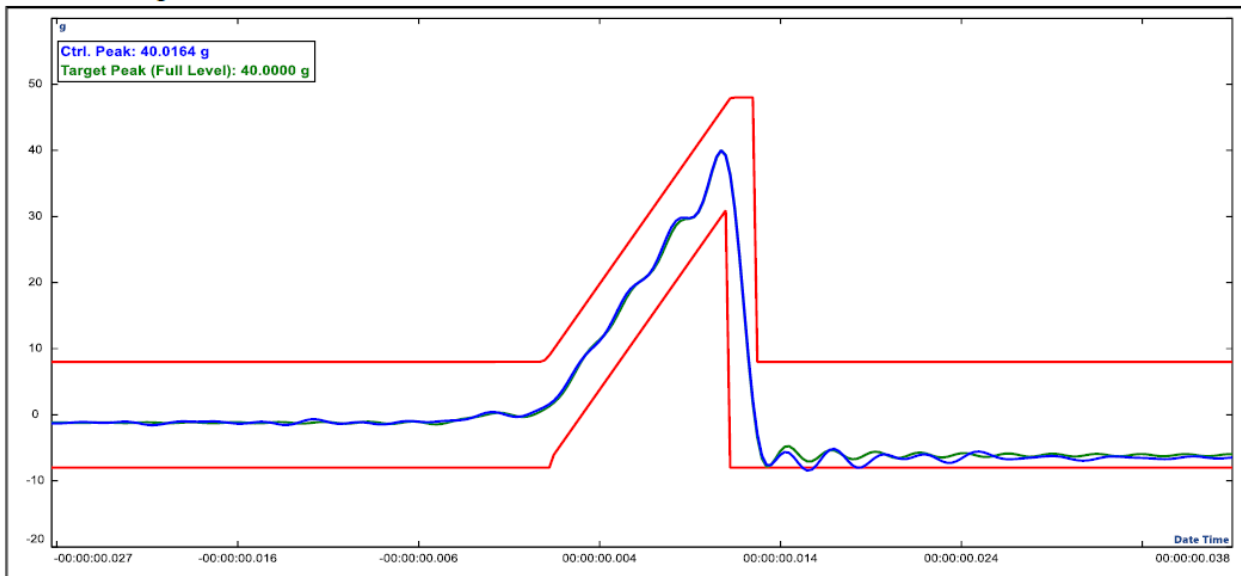
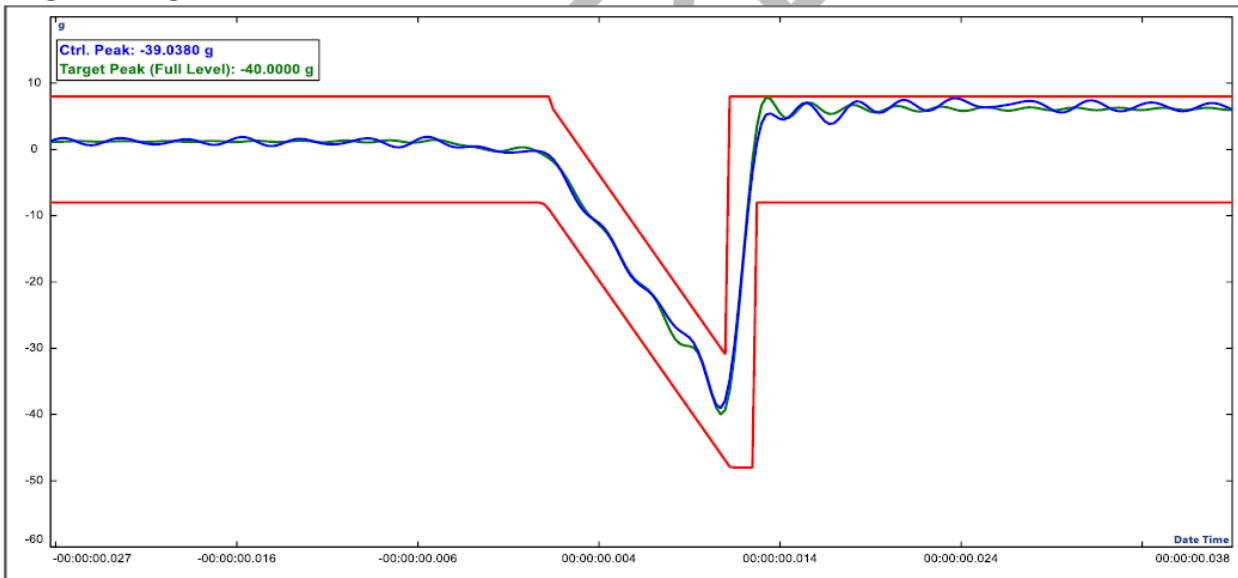
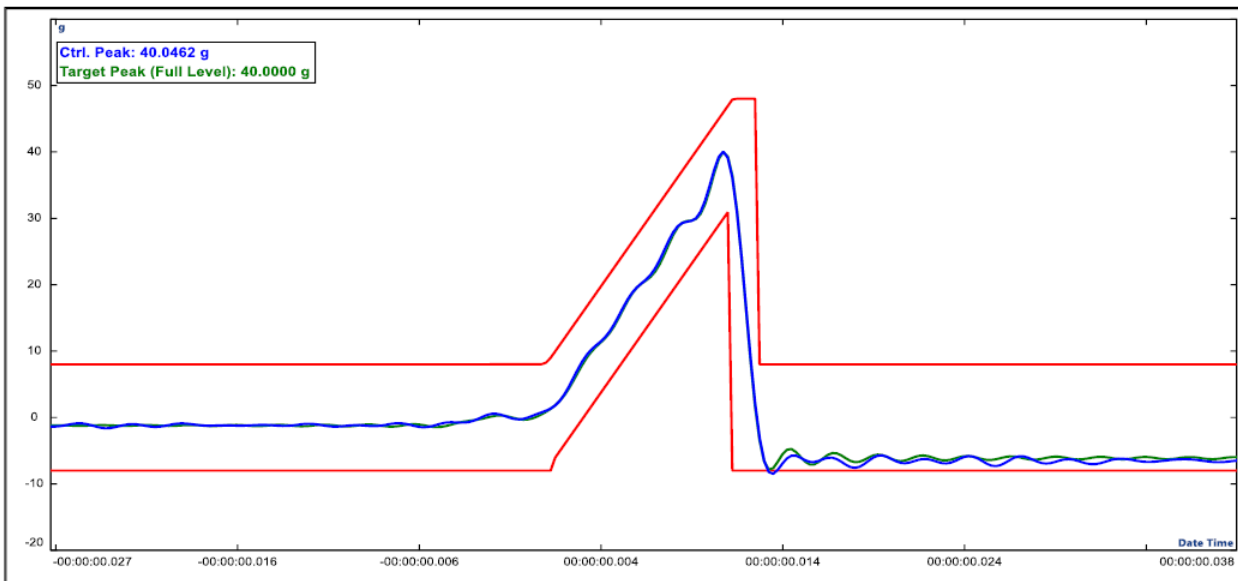
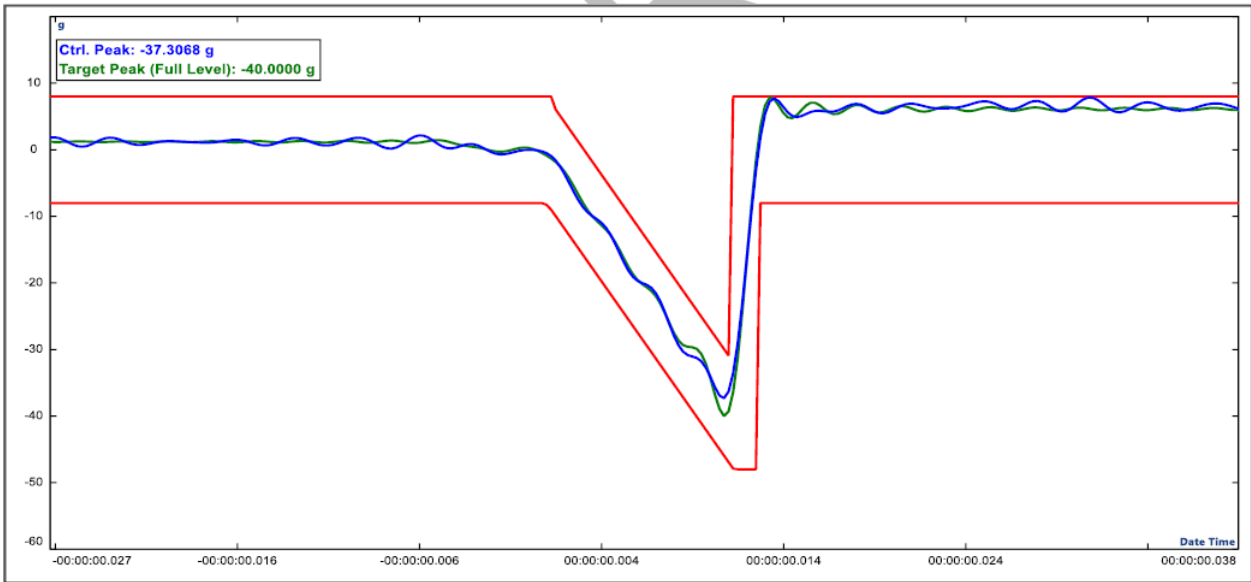
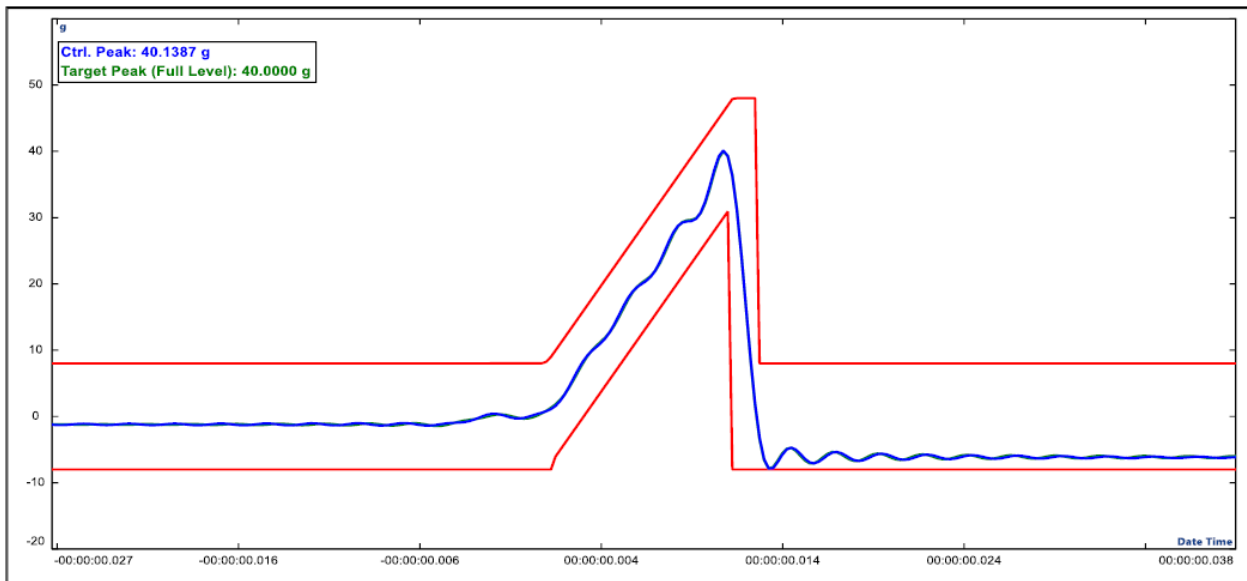
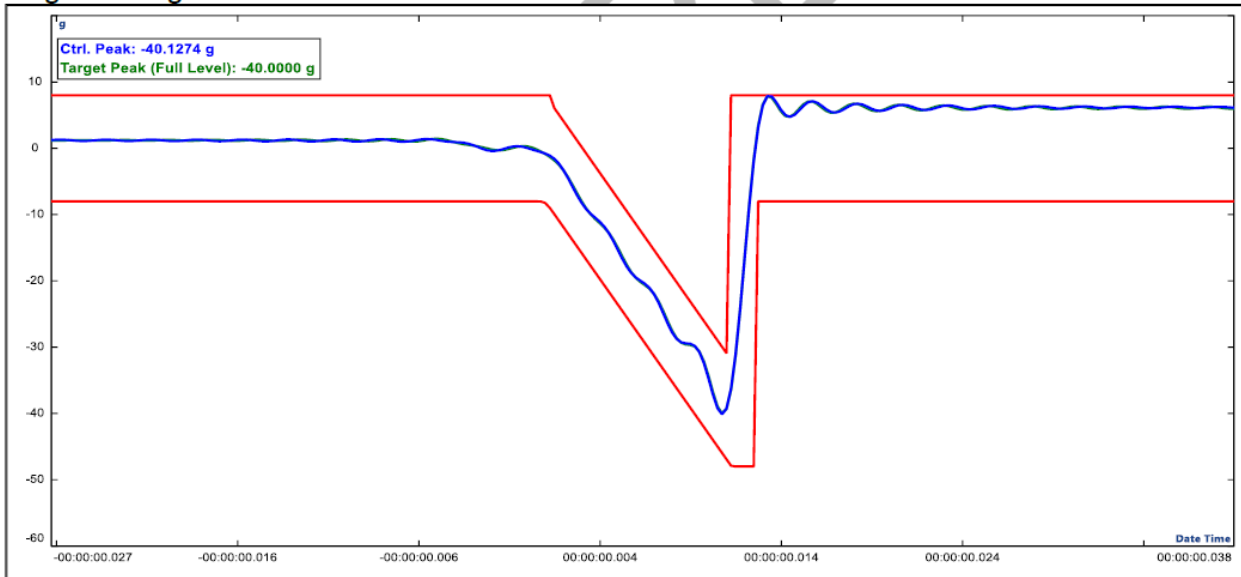
Graph 13:- X Axis 40g 11ms positive direction

Graph 14:- X Axis 40g 11ms negative direction

Graph 15:- Y Axis 40g 11ms positive direction

Graph 16:- Y Axis 40g 11ms negative direction

Graph 17:- Z Axis 40g 11ms positive direction

Graph 18:- Z Axis 40g 11ms negative direction

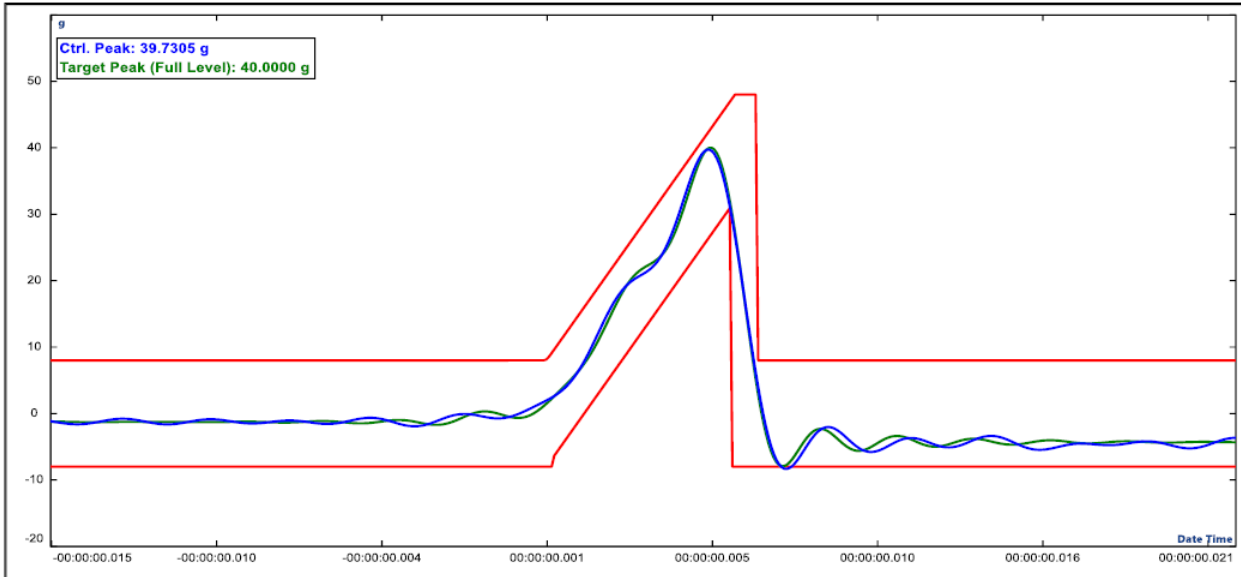
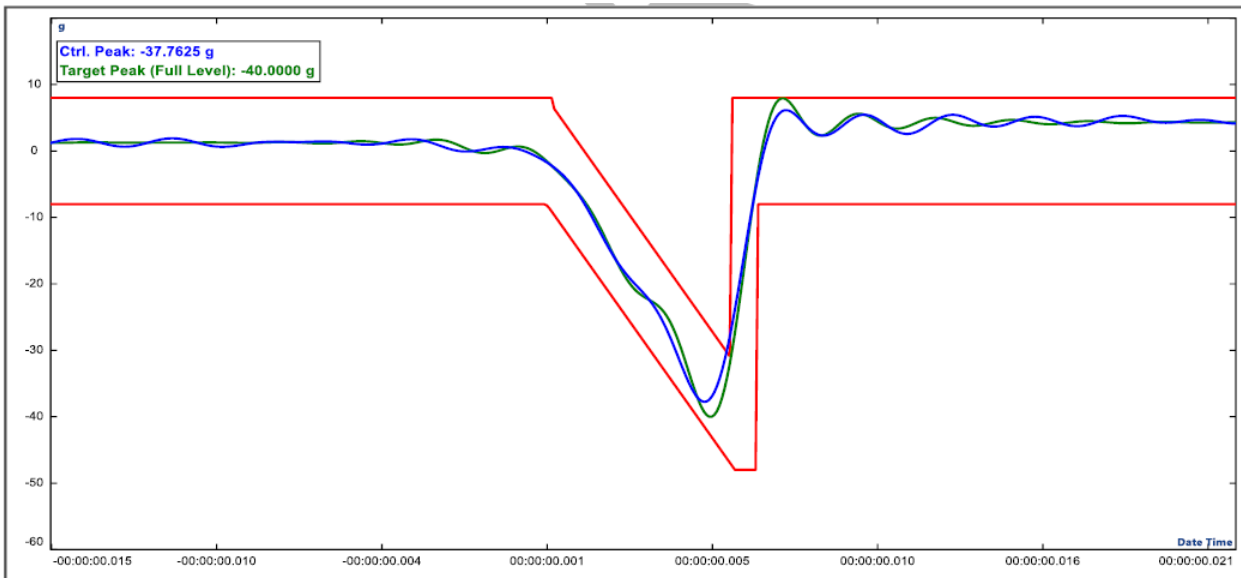
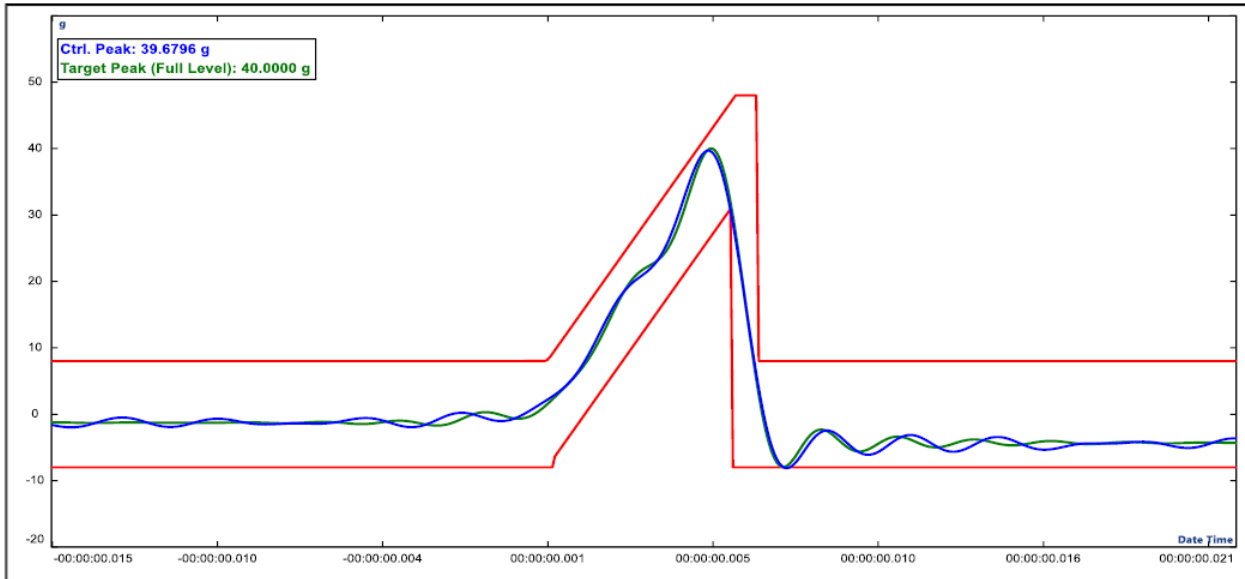
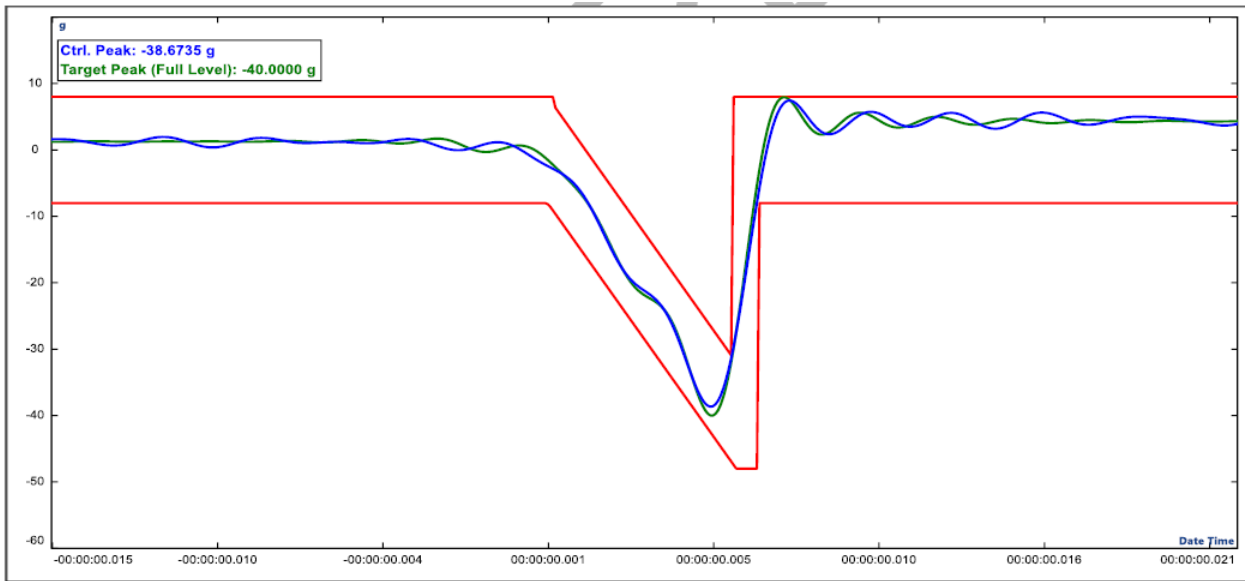
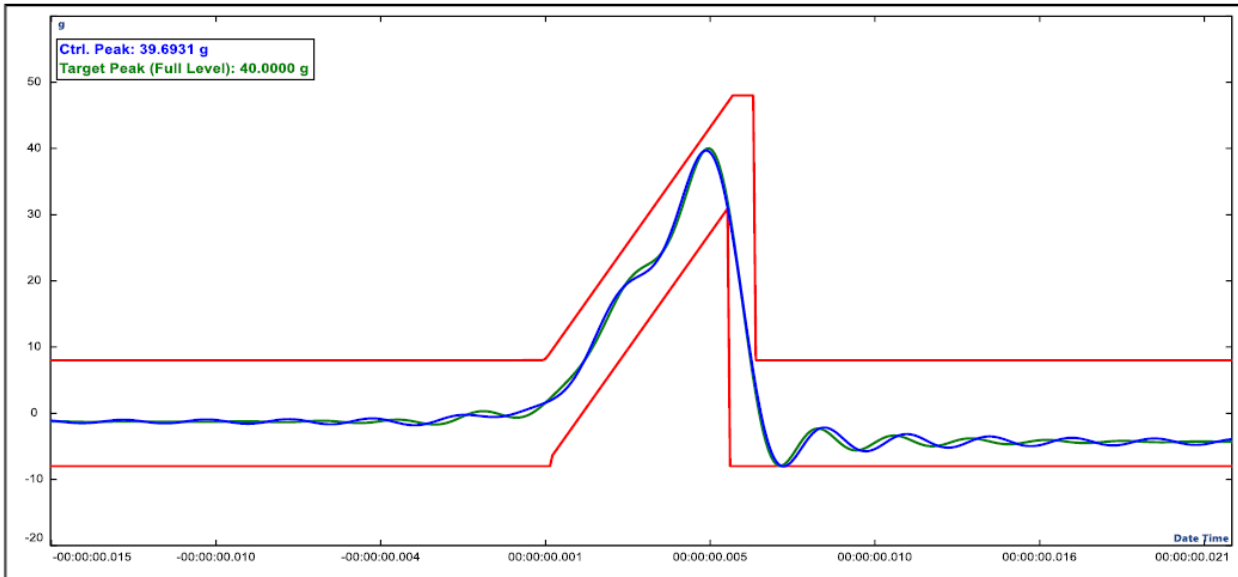
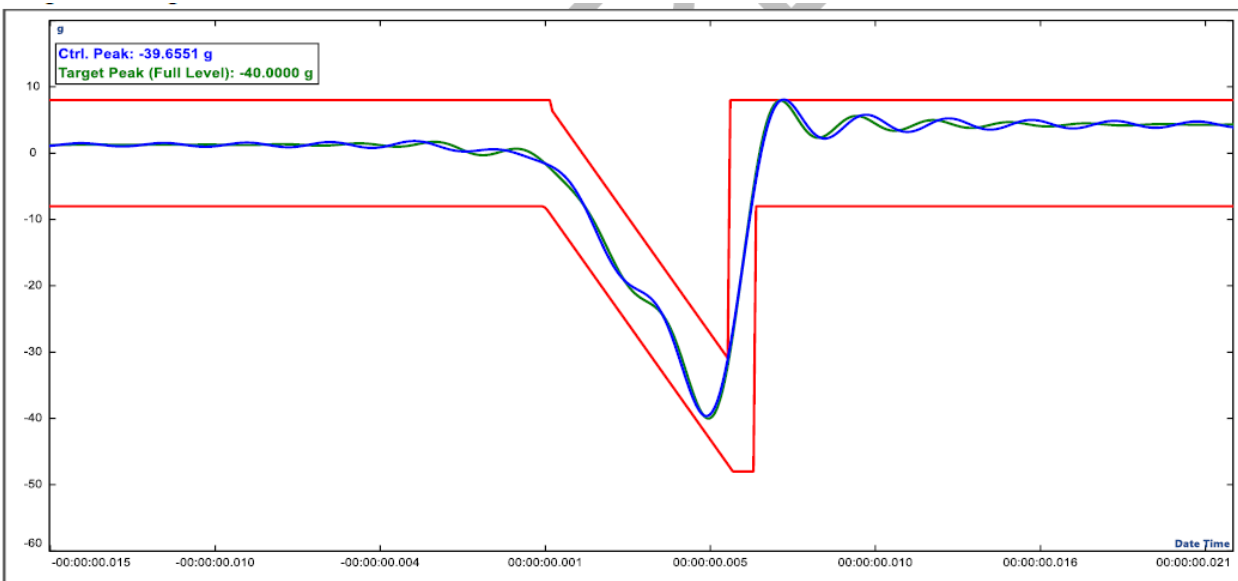
Axis	Peak Acceleration (g)	Pulse width (ms)	Shock Spectrum & No of Pulse / axis
X, Y & Z Axes	40	6	Terminal peak saw tooth, 2 shocks/direction, Total 12shocks.

Graph 19:- X Axis 40g 06 ms positive direction

Graph 20:- X Axis 40g 06 ms negative direction

Graph 21:- Y Axis 40g 06 ms positive direction

Graph 22:- Y Axis 40g 06 ms negative direction

Graph 23:- Z Axis 40g 06 ms positive direction

Graph 24:- Z Axis 40g 06 ms negative direction

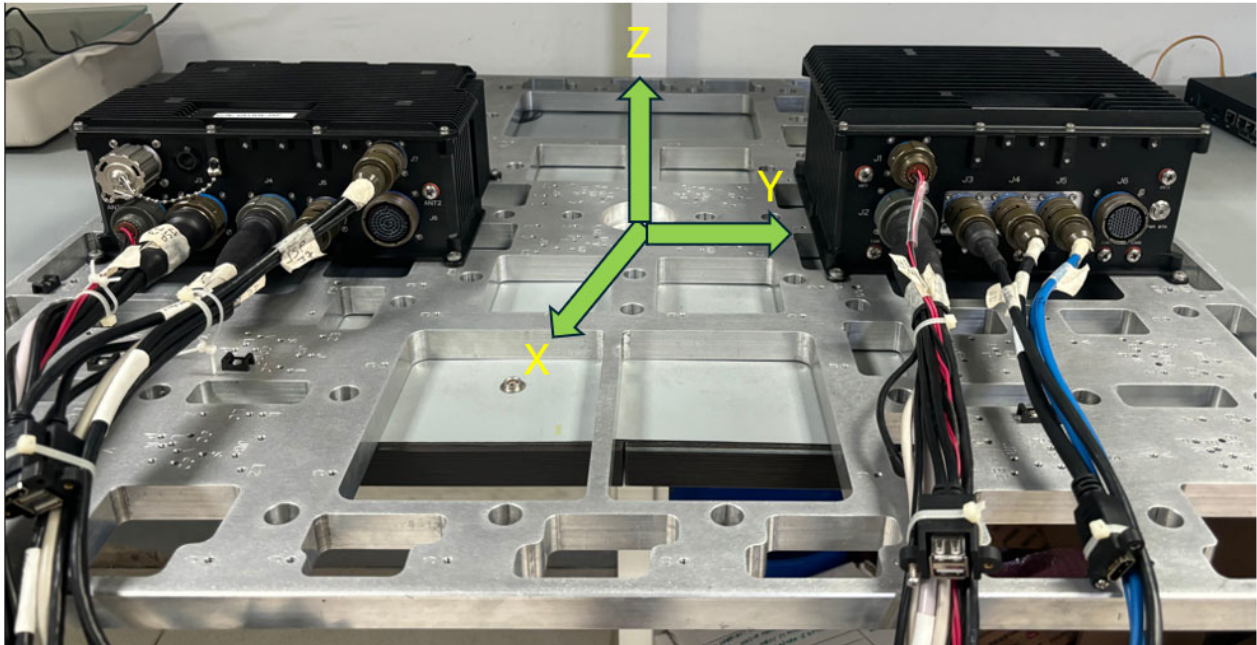
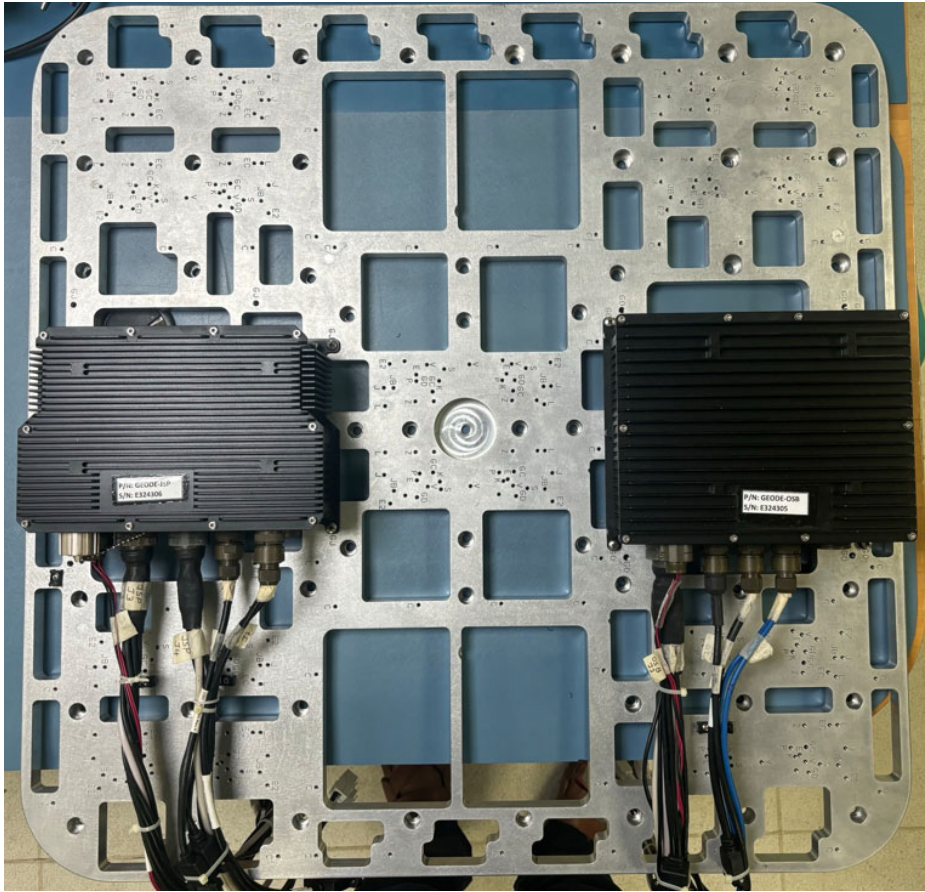
The below pictures depict the test fixture with X, Y, and Z axis positive direction indication. The X and Z axis movement was in forward and backward direction, rotated Geode Osbourne by 90 degrees anti-clockwise and Geode Jasper 90 degree clockwise for Y direction testing after the X direction test. Z axis movement was in upward and downward direction of system.

(The test platform was hollowed out to meet the maximum weight limit of the shaker table.)

Figure 4: Side View of X and Z Axes Vibration Test Setup

Figure 5: Top View of X and Z Axes Vibration test Setup

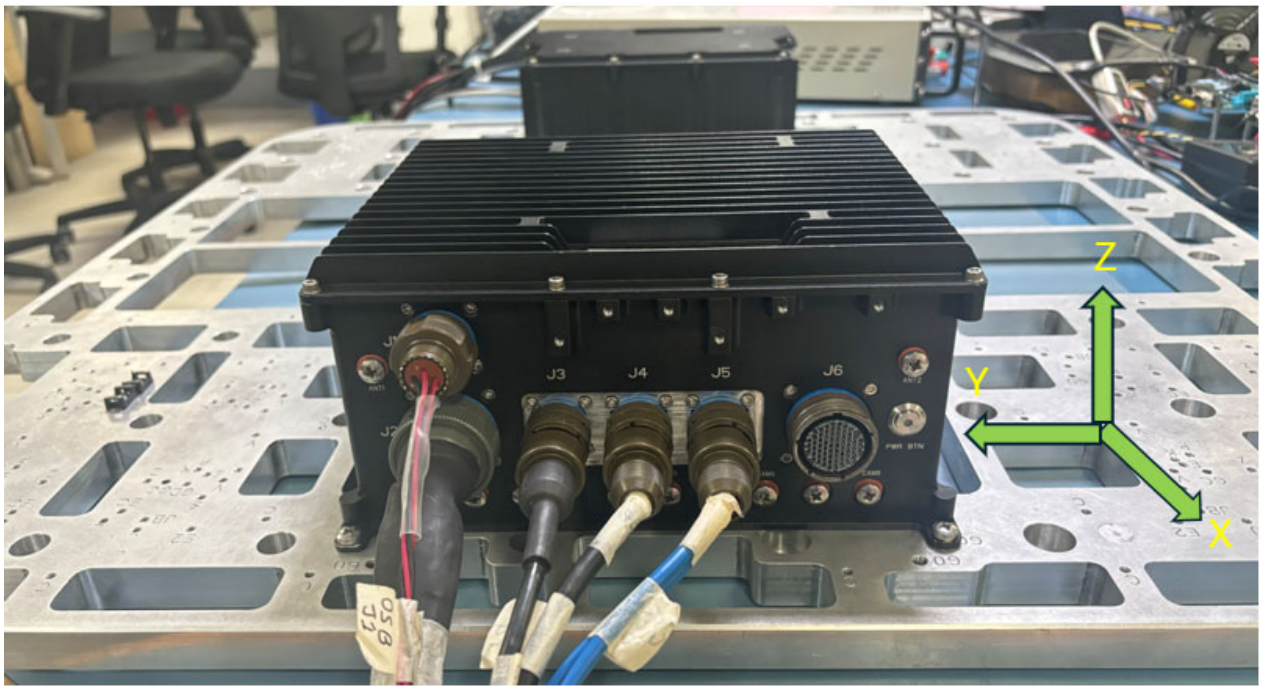
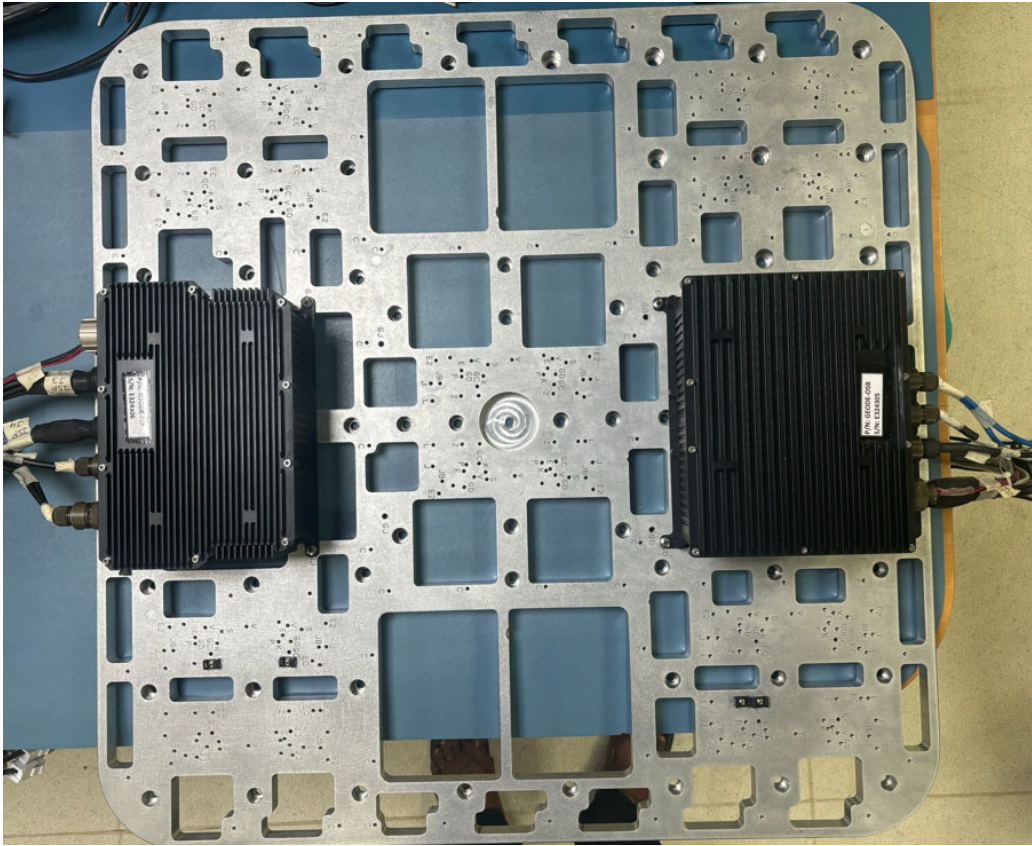
Figure 6: Side View of Y Axis Vibration test Setup

Figure 7: Top View of Y Axis Vibration test Setup
